Manhole Inspection Summary

Manhole # S25M__021MH

Location Address: **1009 S.CAREY ST.**

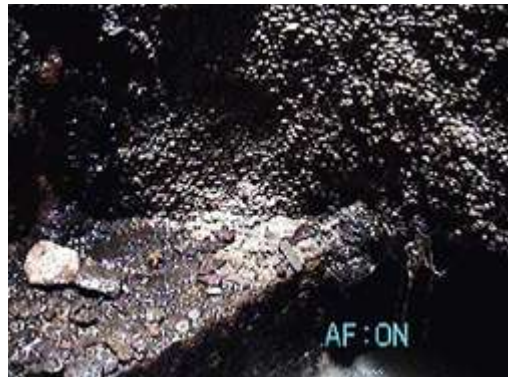
Defect 6

ACTIVE INFILTRATION AT THE
BARREL AND DETERIORATED

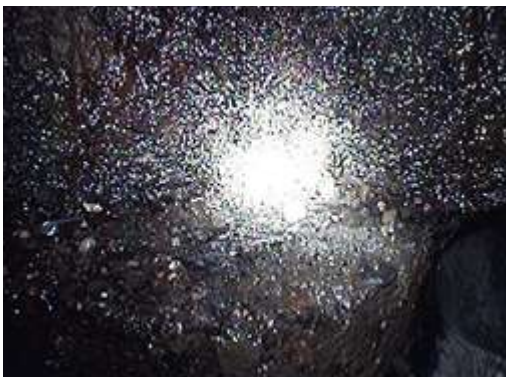
Defect 5

DETERIORATED BARREL AND
BENCH/EVIDENCE OF INFILTRATION

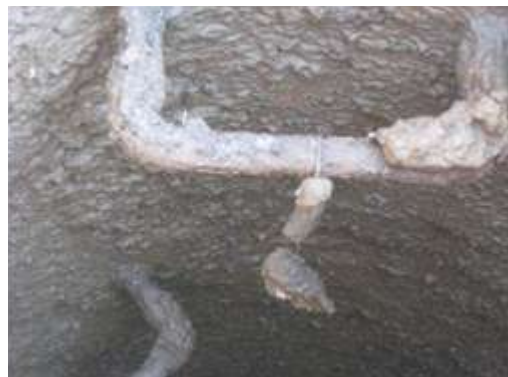
Defect 4

EVIDENCE OF SURCHARGE ON STEP

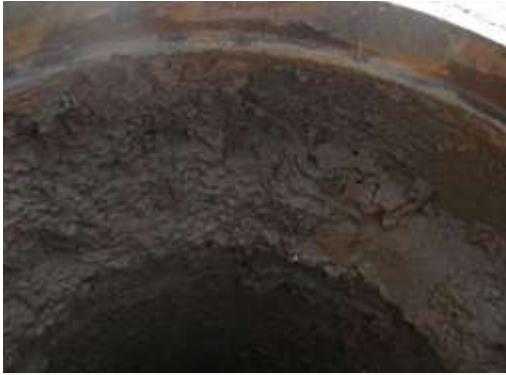
Defect 3

FRAME OFFSET HEAVY MUD ON CHIMNEY TOP

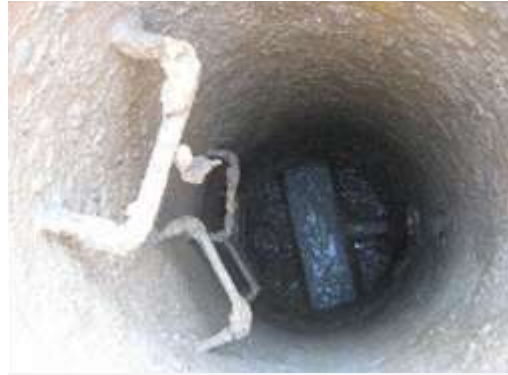
Defect 2

MUD FROM CHIMNEY TO THE BARREL WITH EVIDENCE OF SURCHARGE ON STEP

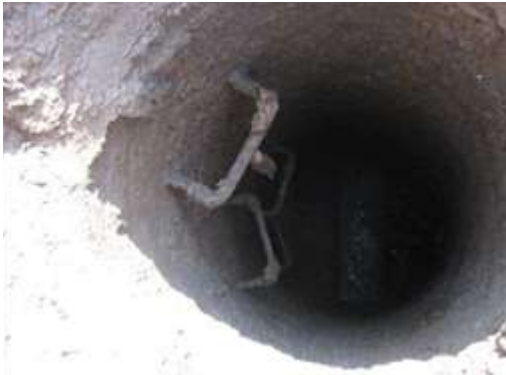
Defect 1

FRAME OFFSET, EVIDENCE OF SURCHARGE ON FIRST STEP WITH MUD FROM CHIMNEY AND CORBEL

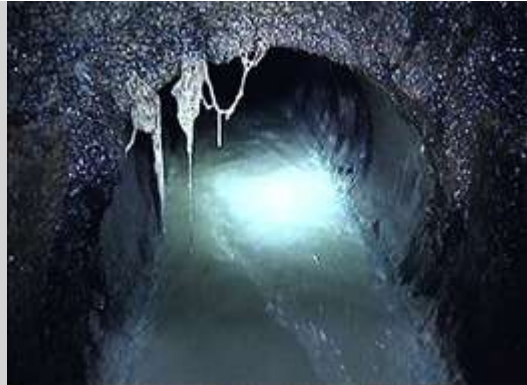
12 O'Clock Outflow

Pipe Height: **20.4** (in.) Rod and Bar (Angled)
Pipe Material: **Clay** ☐ Pipe Lined
Invert Depth: **16.40** (ft.) Flow Characteristics: **Fast**
Deposits: ☒ None ☐ Mud ☐ Sludge ☐ Debris ☐ Grease
Silt Depth: **0** (in.) Deposits Extent:
Infiltration: **Evidence** Pipe Seal Cond: **Unknown**

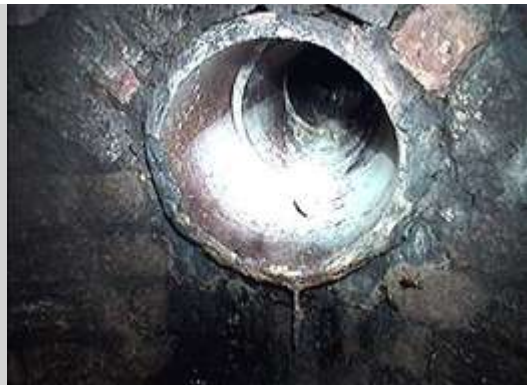
3 O'Clock Inflow

Pipe Height: **8.4** (in.) Rod and Bar (Angled)
Pipe Material: **Clay** ☐ Pipe Lined
Invert Depth: **8.80** (ft.) Flow Characteristics: **None**
Deposits: ☒ None ☐ Mud ☐ Sludge ☐ Debris ☐ Grease
Silt Depth: **0** (in.) Deposits Extent:
Infiltration: **Evidence** Pipe Seal Cond: **Unknown**

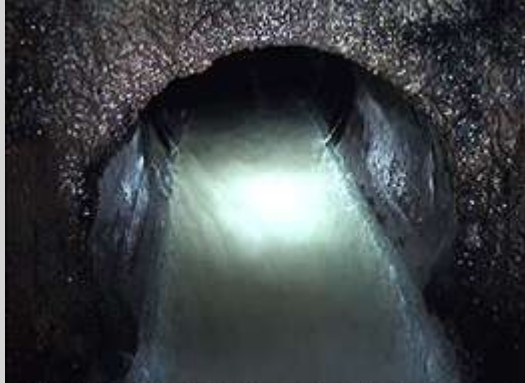
6 O'Clock Inflow

Infiltration: **Evidence** Pipe Seal Cond: **Unknown**
